Field Report no. 2

Survey of Archaeological Remains at  
Svínanes, Reykhólahreppur, Iceland

2011

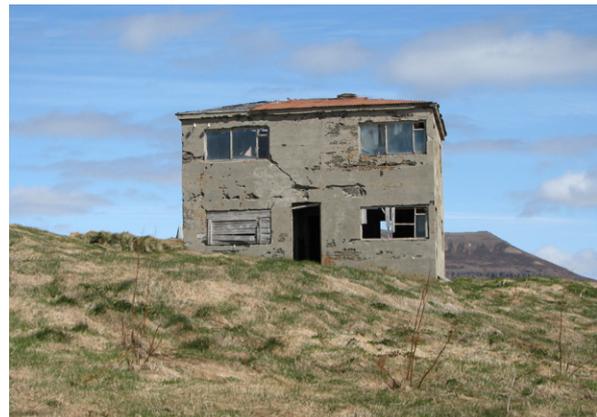
**Illus. 5** Farmhouse from the west in 2007

The farmhouse is a two-storey concrete building constructed in 1943 just a few yards to the east of the site of the earlier house. The earlier site is not readily apparent. According to oral history the earlier building was new when the farmstead was visited by a priest from Flatey in about 1850. The interior of the concrete farmhouse is now derelict, although many of the wooden fittings still survive (Illus 5-7). The corrugated iron roof has been partially blown off by the wind and the concrete structure has suffered from some frost damage.

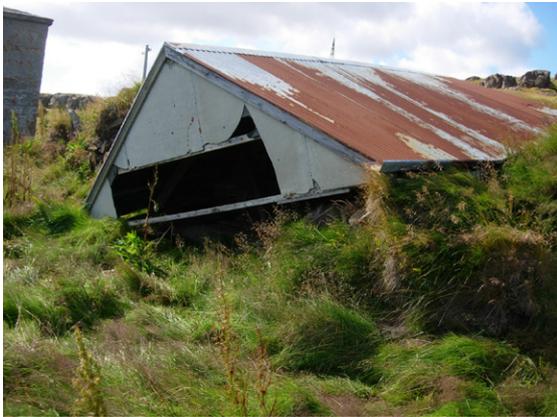
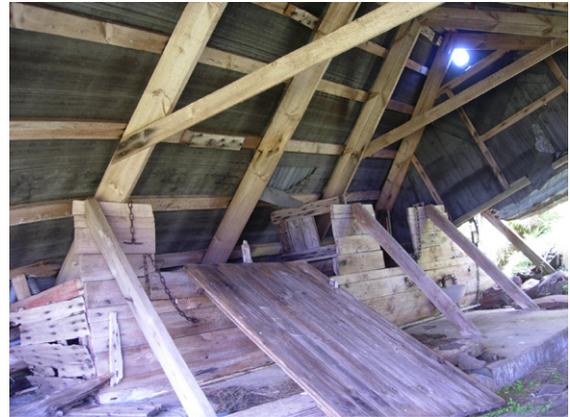
*Illus 8, 9* The partially collapsed structure of the cow house

Two conjoined turf-walled buildings lie to the east of the farmhouse. The nearer is the earliest standing building and was perhaps built about 1900. It was used latterly for smoking meat. The one adjoining it was built in 1954 as a cow house (Illus 8-9). It has a concrete floor and timber mangers and accommodated three cows. It was constructed on the site of an earlier cow house which dated from 1901.

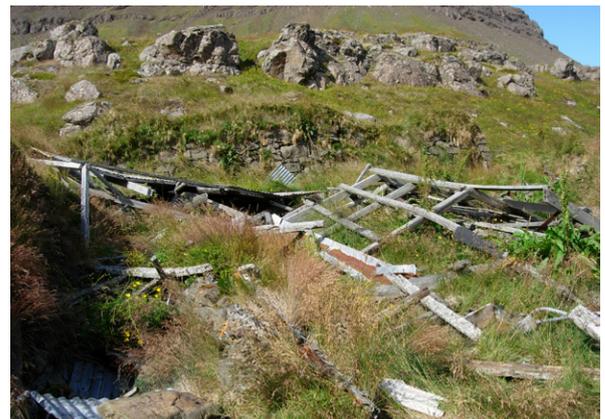
*Illus. 10* Dairy and tractor shed

A dairy and temporary tractor shed were constructed of timber and have now been entirely blown down (Illus 10).

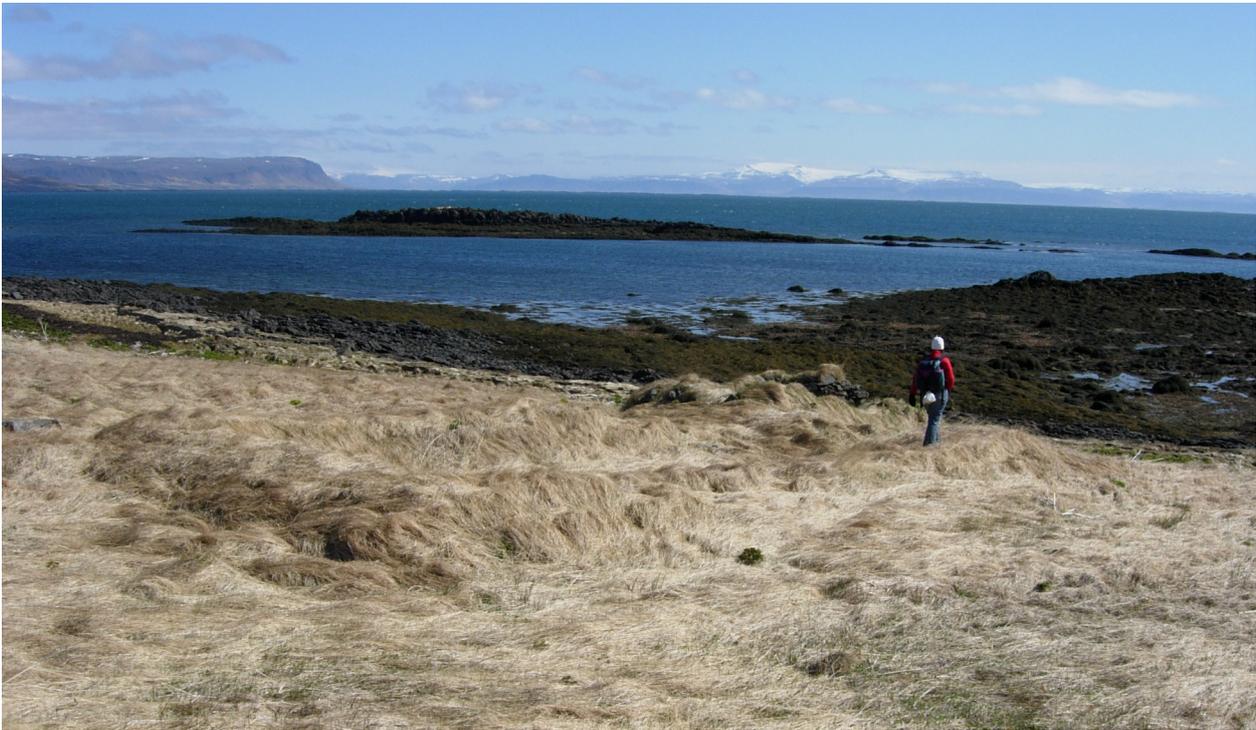
*Illus. 11* The ‘German building’ – a large turf-walled building associated with Hanseatic traders

External measurements: 13.1m by 7.6m. Internal measurements: 9.4m by 3.5m.

A rectangular turf-building lies on a gentle slope a short distance from the sea (Illus 11). The entrance is to the south facing the sea. There is some evidence that the walls of the building were faced with stone, although it is so overgrown that this is impossible to confirm. There is some damage or possibly a second entrance on the east wall near the south-east corner.

The identification of this as the ‘German building’ is traditional and it is said that the building served to store goods for traders. The building is of unusual width and is also notable for being built on a slope, which would have been difficult if it had been a house, though, of course, it would not precluded its use for animals. The name of the adjoining cove, *Kumbaravogur*, is notable since this means the ‘cove of the cogs’. A cog was a common type of European trading vessel. The traditional identification and the place-name provide supporting strands of evidence that this building was associated with foreign trade. Cut into the south side of the building is Site 11.

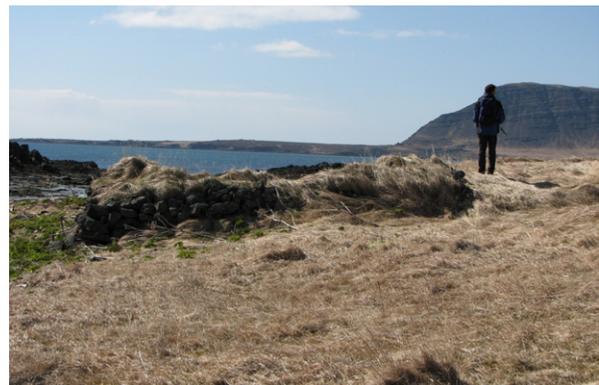
*Illus. 12* A turf-walled building used for storing the possessions of the farm-labourers looking west

External measurements: 6.9 m by 4.1 m. Internal measurements: 4.0m. by 1.5m.

A small building is cut into the south-east corner of the German building, and is probably later (Illus 12).

The walls have internal and external stone-facing with a earthen core. The entrance which lies to the south is now very narrow, but it is possible that it may have originally been across the full length of the building. Before the abandonment of the farm, it was used for storing the possessions of farm labourers.

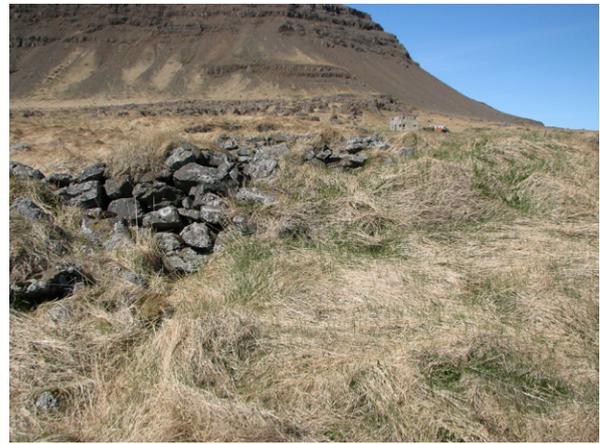
*Illus. 13* Smithy, later tractor building with blocked doorway

External measurements: 8.9 m by 6.6 m. Internal measurements: 5.4m. by 1.7m.

A short distance to the east of Sites 10 and 11 is a turf building with stone-lined interior on the eastern half of the north wall (Illus 13). It was used as a smithy by Bergljót’s grandfather who died in 1917. The door to the south was subsequently blocked

with stone and the west wall removed to provide shelter for a tractor. Subsequently that wall was replaced. The earlier usage of the building is also implied by the name of the headland, Smiðjutangi.

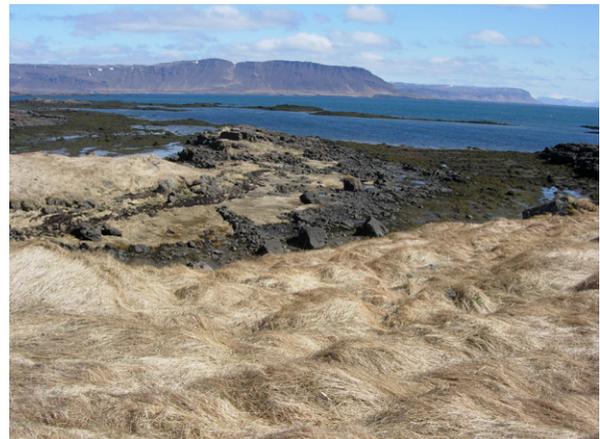
*Illus. 14* Inlet showing the breakwater and nausts. Beyond these on the headland is the fish-drying building (16)

A series of maritime structures were recorded near to the shore to the east of the farmstead. The inlet to the south-east of the farm was used for keeping fishing boats by Bergljót's father and the head of the bay is partially protected by a small stone breakwater (14) (Illus 14-15). The smaller of the nausts lay to the south-west and was used in winter for keeping boats when there was ice on the fjord, according to Bergljót (Illus 16). It could have only accommodated a small boat. It is marked only by a shallow depression. The larger naust has stone-edged walls supporting the base of a turf-building. It appears to cut a further naust to the east which sat on the edge of the cliff.

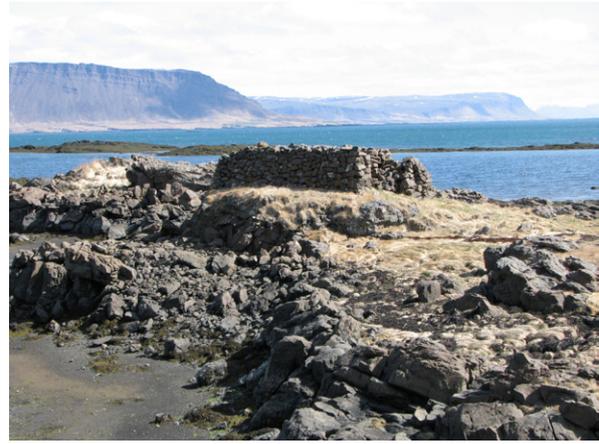
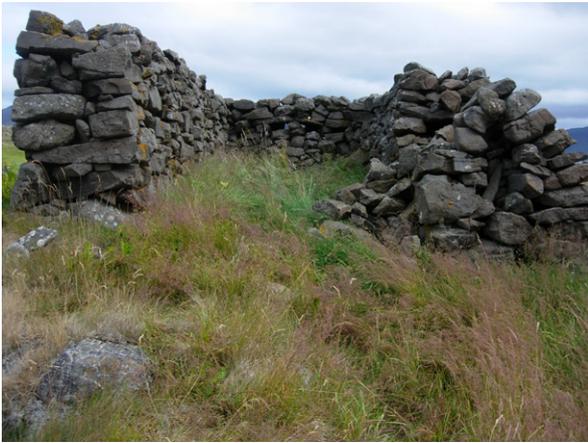
Illus 17 Fish-drying building, view from the west

Drystone buildings were commonly used for drying and storing dried fish in the past (Kristjánsson 1985, 289-96). A drystone-building on the exposed headland south of the farmstead was used for this purpose (Illus 17-18). The building is orientated west-east with the door to the west and three small apertures in the east wall to allow wind to blow through. The walls are about 1 metre thick and barely coursed. There is some evidence for rebuilding on the south side where there is some poor, uncoursed work. The wall at the east end is thinner than the side walls and there is some evidence that it has been rebuilt.

Illus 18 Fish-drying building, views from the west and south-west

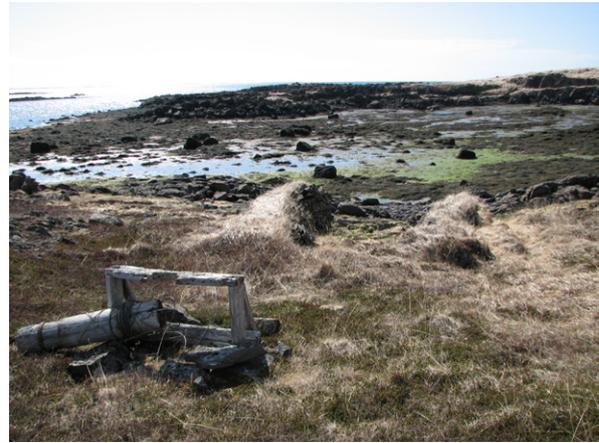
Illus. 19 Capstan and beyond it the stone-walled naust building

A large, well-built naust faces the third bay, to the east of the farmhouse (Illus 19-20). It was built with drystone, barely coursed walls and has a clear ramp leading to the water. Bergljót says that boats were hauled up on whale-bone runners. There is a timber capstan with steel cable to the east of the naust and beyond that a further setting, evidently for an earlier capstan beyond it

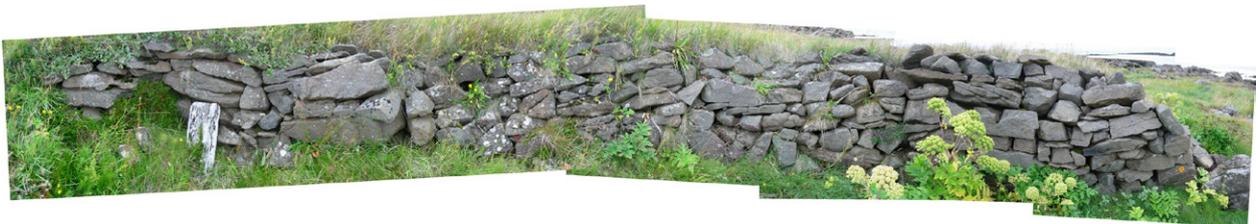
Illus. 20 Pseudo-orthophoto of the south-east side of the wall of the naust showing different types of walling, suggesting periods of reconstruction and repair

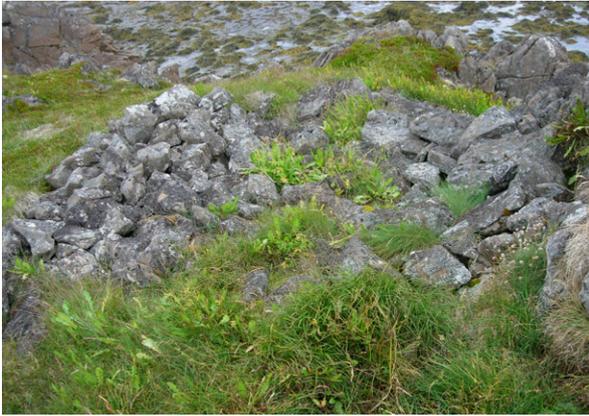
*Illus. 21* Hide or fold on Kálfhólmi

The first of the islands sites occupies a natural horseshoe of rocks and is a small enclosure or hide

(Illus 21). Bergljót suggests that it may have been a hide for shooting foxes venturing near the farm and eating eider ducks. Alternatively, it may have been a small fold. Above the structure is a cairn of stone.

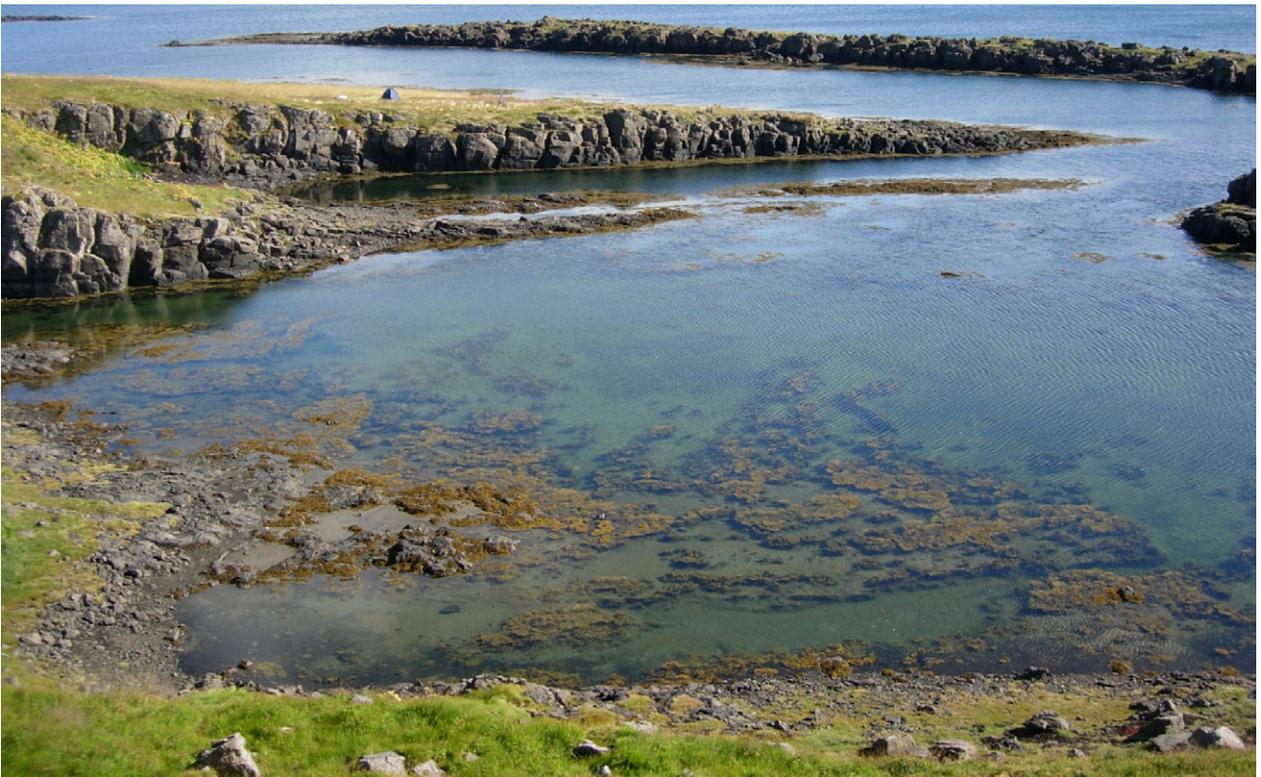
*Illus. 23* The bay at Kumbaravogur with the landing place on the far side and the reef of Kumbaratangi just emerging from the water

The main landing place at present is the bay of Kumbaravogur where a natural wall of rock provides a useful point against which boats can be brought up (Illus. 23), and is a convenient point for loading and unloading vessels (Illus. 24). However, the bay does not provide a deep-water landing and at low tide is almost empty. The entry to the bay is difficult for larger ships, so it is doubtful whether it would have provided an anchorage for cogs or other vessel types. It may be significant that the ‘German house’ does not face this bay.

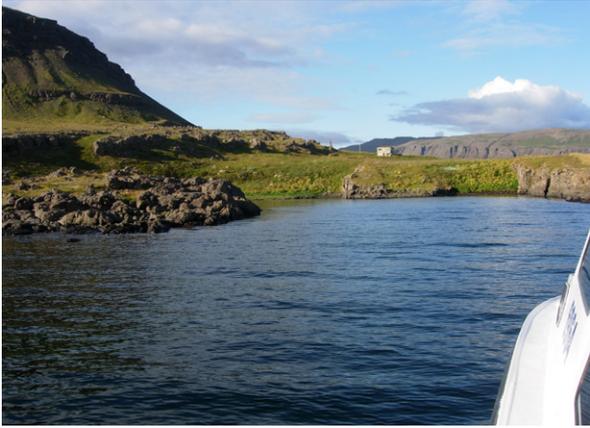
*Illus. 25* The enclosure of Svínabæli projects into the bay at Kumbaravogur. The landing-place is on the right-hand side of the bay out of the picture. The farmhouse is visible in the far distance

This large enclosure stands on a sharp slope directly above a reef (Kumbaratangi) exposed at low tides in the inlet of Kumbaravogur (Illus 25). The enclosure relies partly for its boundaries on the ridge of rock. It takes its name from the pig enclosure which Geirmundur was supposed to have established at Svínanes after the settlement of Iceland (*Landnámabók*, 58-59). It is surrounded by an earth bank on the west and north sides, and a stone wall on the east. A further earth bank prevents any animals from escaping over the low cliff towards the sea to the south. No entrance was recorded.

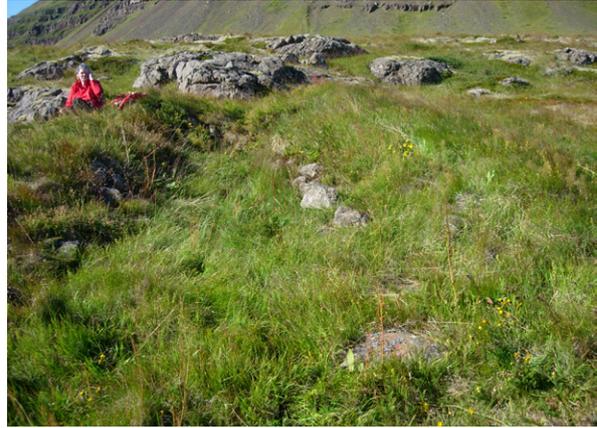
*Illus. 26* The naust on the south-west of the farmstead, showing Bergljót Aðalsteinsdóttir on the left-hand side

A further naust lies to the west of Kumbaravogur. It has stone-faced internal earthen walls. There is a hole at the north end for a cable to haul up boats (Illus 26).

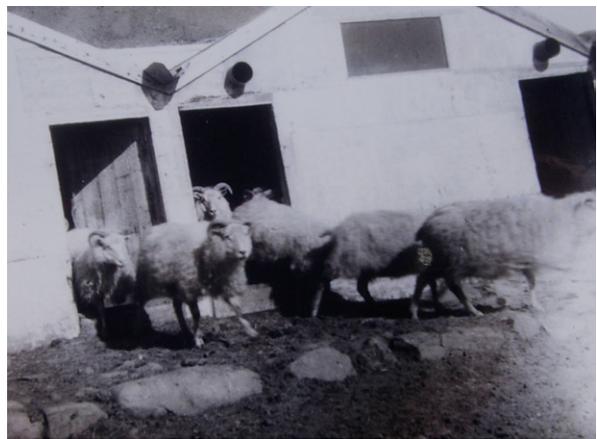
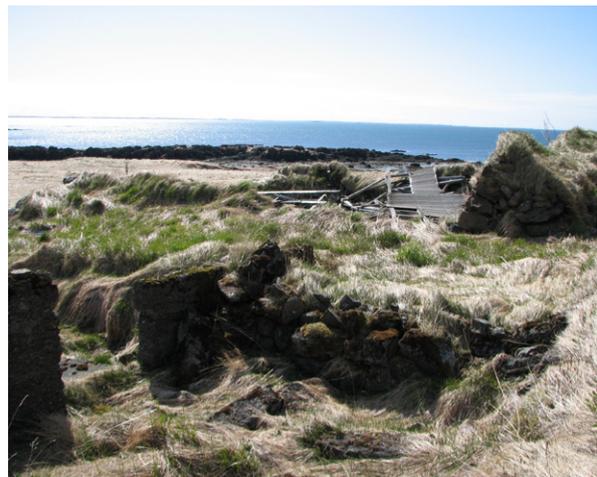
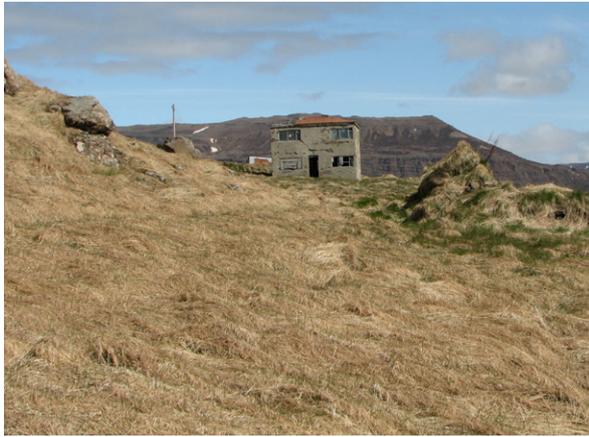
*Illus. 28* Photograph from the 1950s showing the sheep house

*Illus 29* Ruins of the sheep house and hay store

The farm at Svínanes kept a flock of 200 sheep in the 1940s. The sheep house was built between 1948 and 1950 with stone from the old farmhouse (Illus 28-30). The north wall is better built than the east wall. It was constructed in a combination of concrete and stone which was experimental and not entirely successful. The hay was kept in a storehouse to the north, the roof of which is just visible in Illus. 28 and more clearly apparent in the cover illustration.

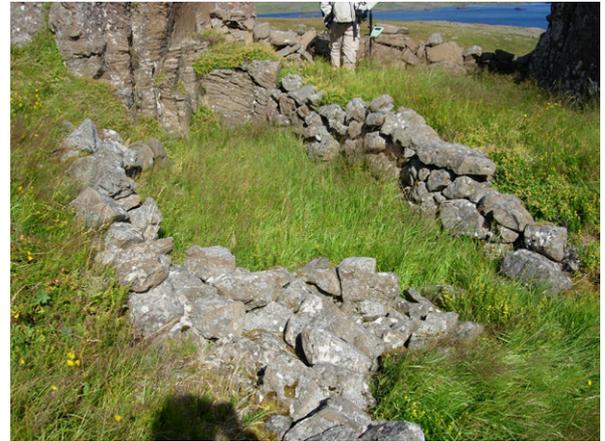
*Illus. 31* Sheepfold under the mountains for ewes

There was a sheepfold (26) under the mountains where the ewes were kept immediately after lambing and it was perhaps 200 to 300 years old (Illus 31). A later sheepfold was constructed next to the home field wall (27) (Illus 32).
